**Conditions:**

35 years old woman with breakage of palatal cusp of the second premolar at the bone level after root canal treatment

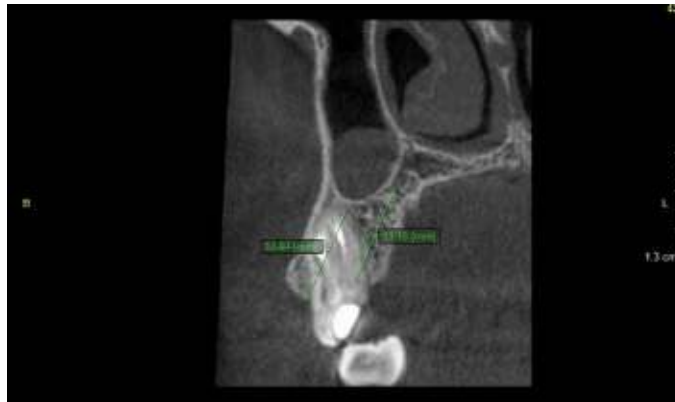
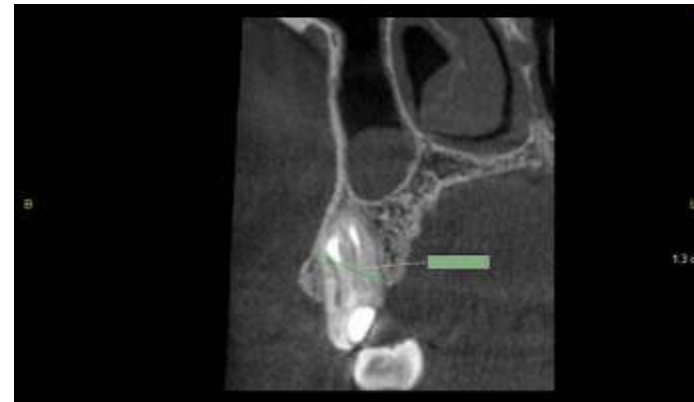
Before procedure precise diagnostic of the conditions was considered. CT scans soft tissue thickness and bite relationships were evaluated.

Additionally, The impression was taken to create a temporary restoration

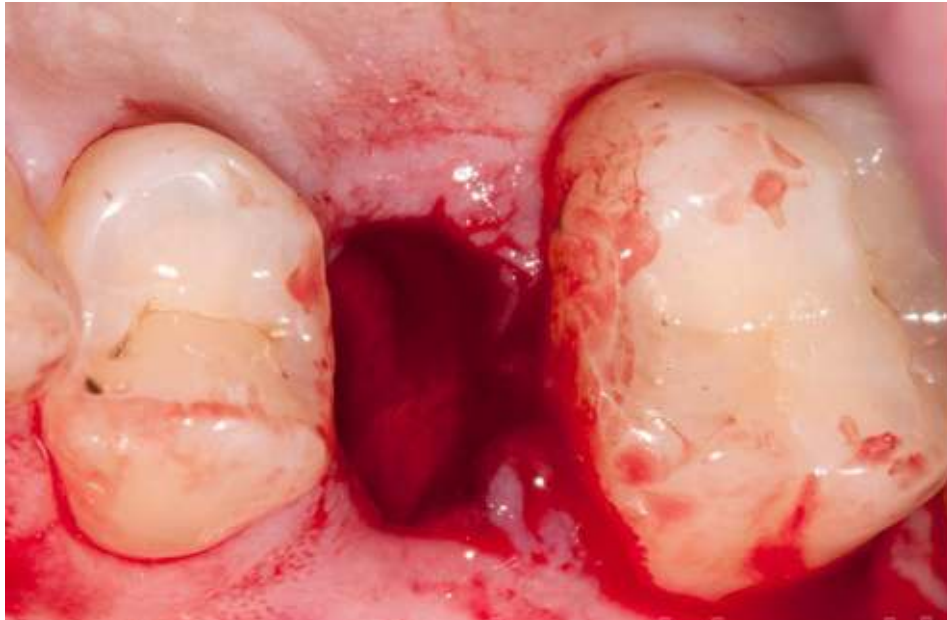
*Extraction Site*

The surgery began with a careful extraction of the damaged tooth .

The intact extraction socket is mandatory to continue the procedure.  
The implant size and drilling sequence should be adapted to individual socket dimensions and implant parameters

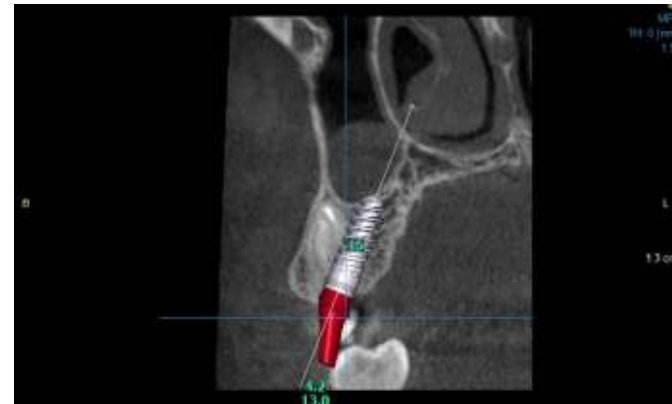
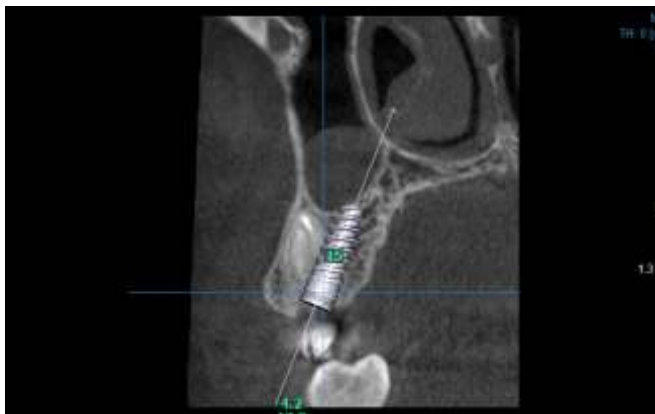
Additionally, according to the CT scans, implant length chosen was appropriate to achieve bicortical stabilization of the implant. The initial position of the implant long axis is about 45 degrees

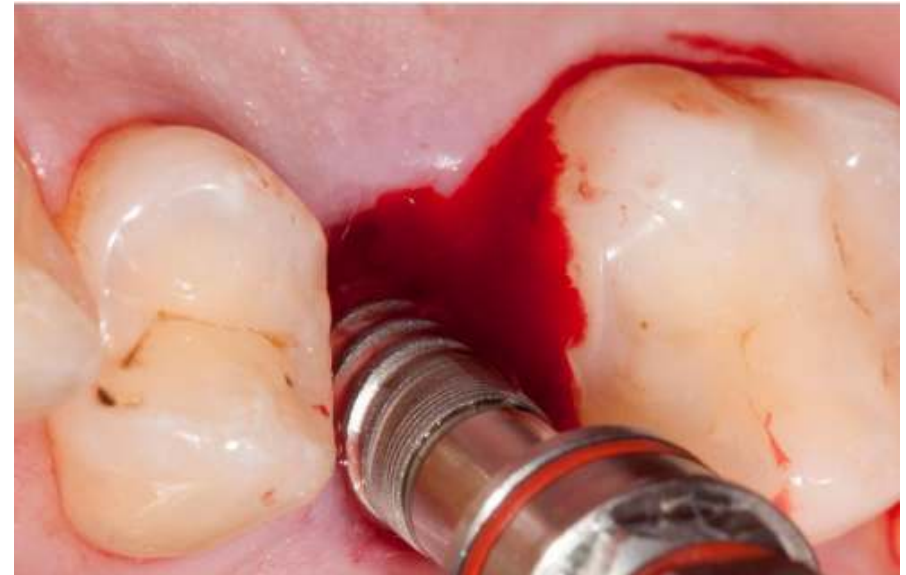
*Implant Insertion 2*

subsequently during the placement final angulation  
reached a value of 15 degrees

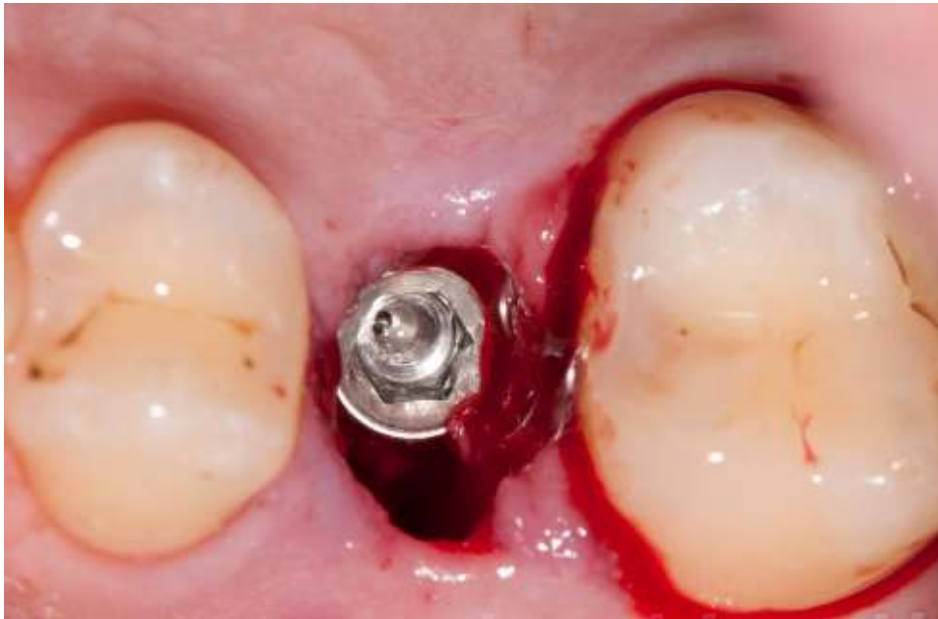
*Final Implant Position*

Vertical implant position should respect the dimensions of the biological width.  
The gap between the implant and the buccal wall of the extraction socket was filled with bovine bone material

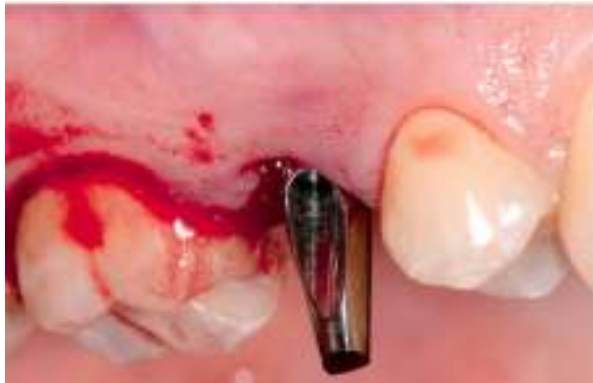
*Abutment Matching*

For temporary restoration the standard titanium abutment of 15 degrees was used (according to the paraguide).  
After trimming to the individual bite relationships

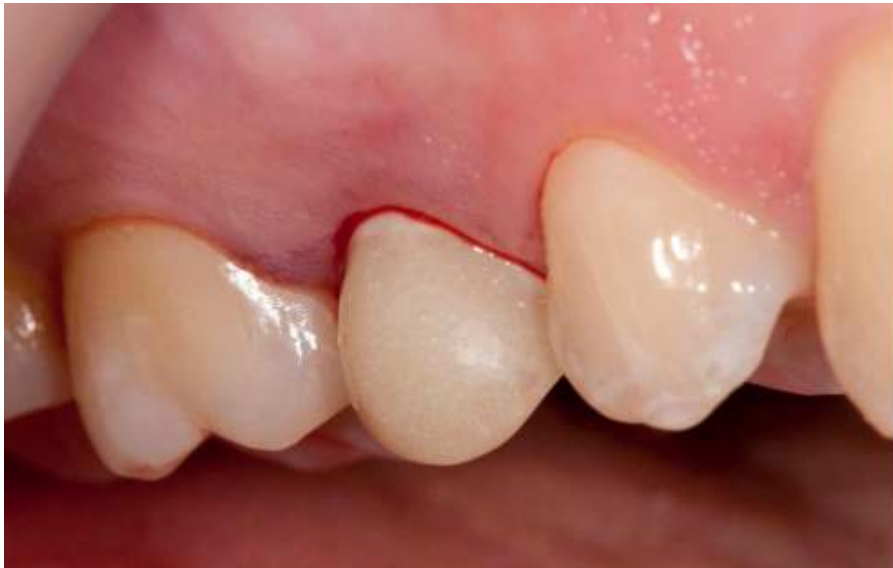
*Immediate Restoration*

The composite crown was mounted using self curing composite and registration key

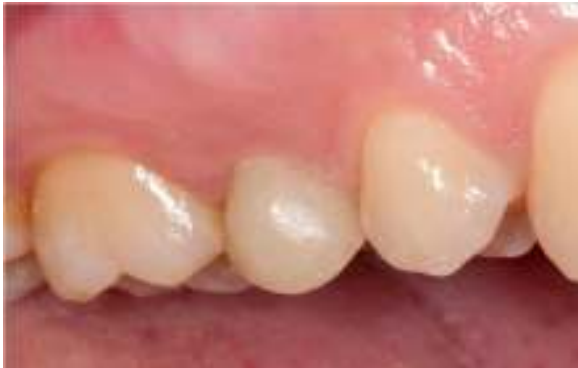
*4 days*

The following pictures show clinical conditions after the procedure of 4, 10, 18 days of the healing period

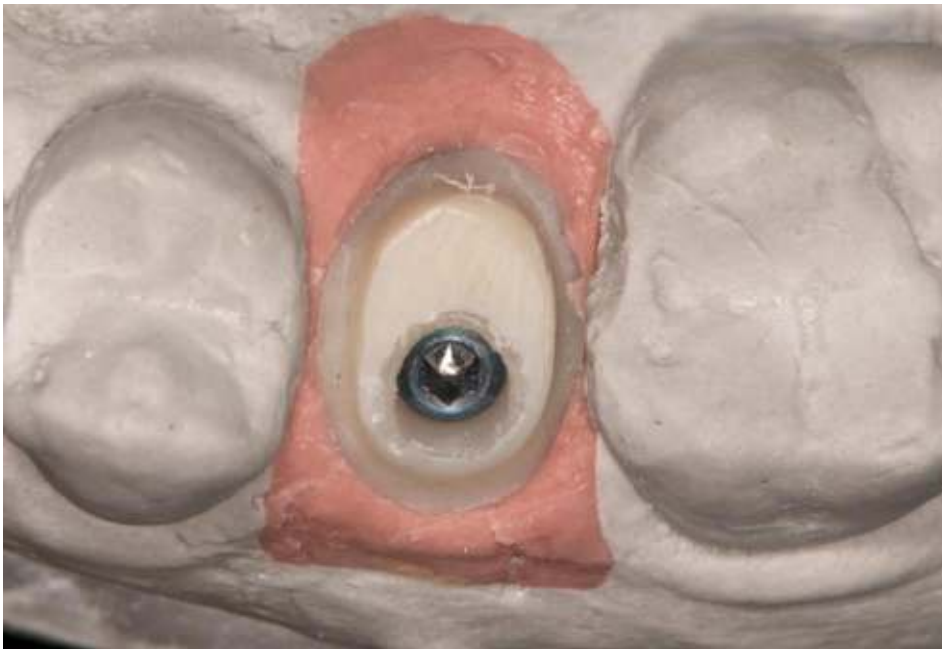
After 6 month of healing the impression was taken for the final restoration. In the beginning the composite customized abutment was created to copy the unique shape of the emergency profile achieved during the healing period.

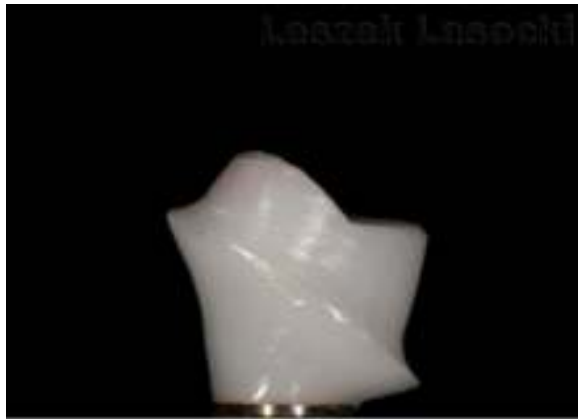
*Abutment*

Next the composite abutment was mounted to the implant to check its shape and soft tissue behavior. Then the composite abutment was copied to the zirconium oxide abutment and zirconium oxide superstructure was created for future ceramic crown.

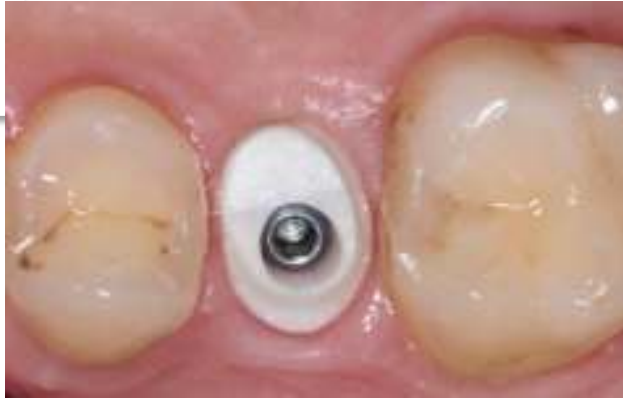
*Customized Abutment*

Prosthetic procedure finished with cementation of ceramic crown and the control x-ray
